## Kemper Center Shoreline Protection Design Case Study

*Title of Project:* Kemper Center Shoreline Protection Phase III

*Organization:* Kenosha County Division of Parks

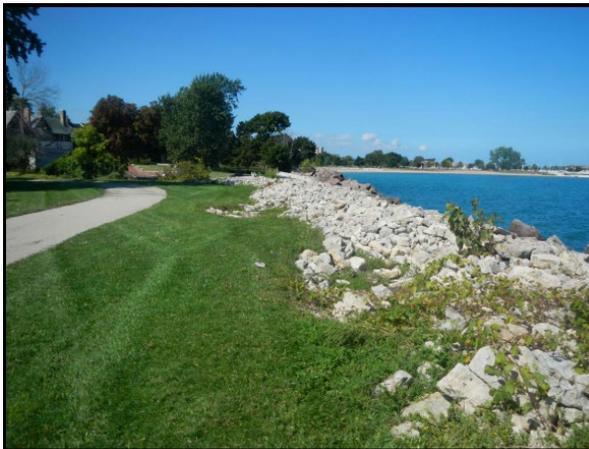
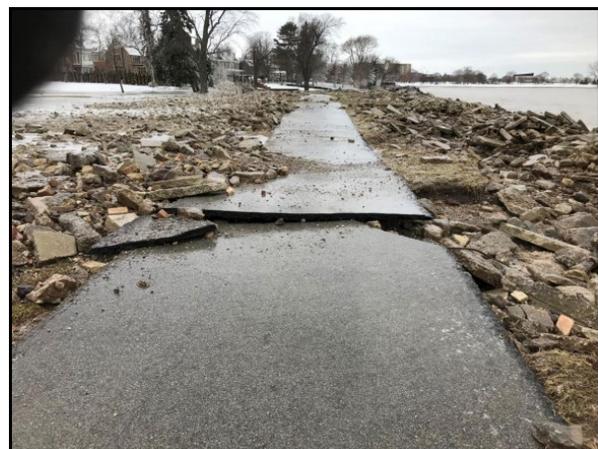
Kemper Center shoreline before (left) and after (right) the January 10-12<sup>th</sup>, 2020 storm [photo by Kenosha County]

The shoreline of the Kemper Center currently consists of a degraded stone revetment that no longer provides an adequate level of protection from the combination of coastal storms and lake level fluctuations that are routine on this stretch of Lake Michigan. The revetment, bike path, and park grounds were damaged during major storm events in 2015, 2016, and 2020. The January 2020 storm caused enough damage across Kenosha, Racine and Milwaukee Counties to qualify for a FEMA Major Disaster Declaration (DR-4477). Wave overtopping during these storms has displaced significant amounts of revetment material landward onto the lawn, path and parking lot, requiring removal with heavy equipment. In the January 2020 storm, it is estimated that almost 3000 tons of stone were displaced an average of 41 feet landward. Waves overtopping the revetment have also caused localized flooding on the path and surrounding landscape. With every large storm, the revetment continues to degrade through the displacement of armor stone and subsequent lowering of the crest elevation. This leaves the Kemper Center and its grounds increasingly vulnerable to coastal erosion and flooding.
